CALSPAN AIR BAG DEPLOYMENT INVESTIGATION

CALSPAN CASE NO. CA96-21

**VEHICLE #1 - 1995 FORD ESCORT
VEHICLE #2 - 1988 CHEROKEE LAREDO**

LOCATION - STATE OF NEW HAMPSHIRE

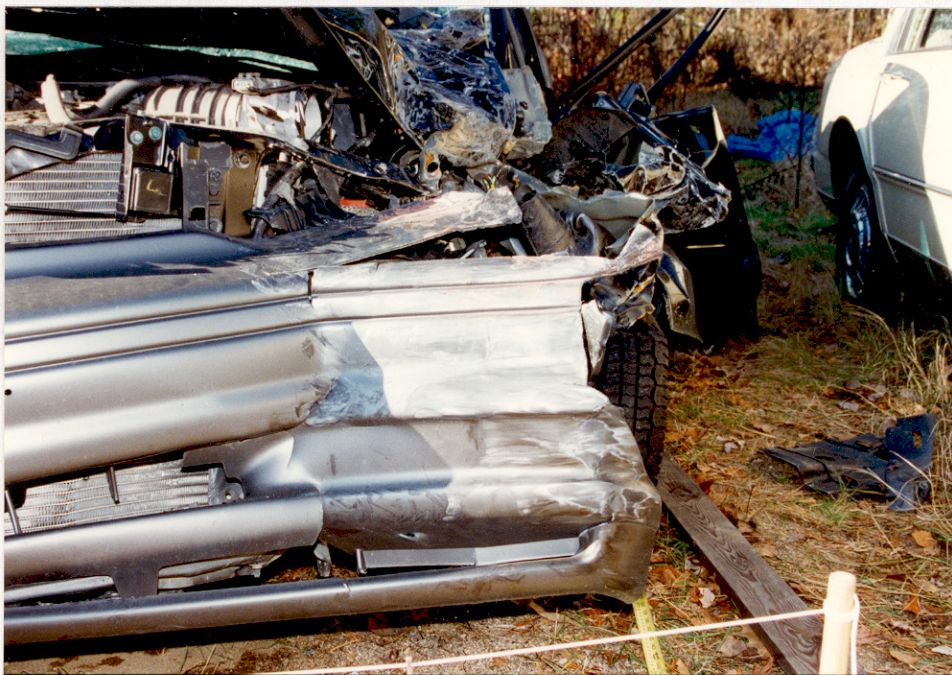
42. Overall view of the 1995 Ford Escort's frontal plane.

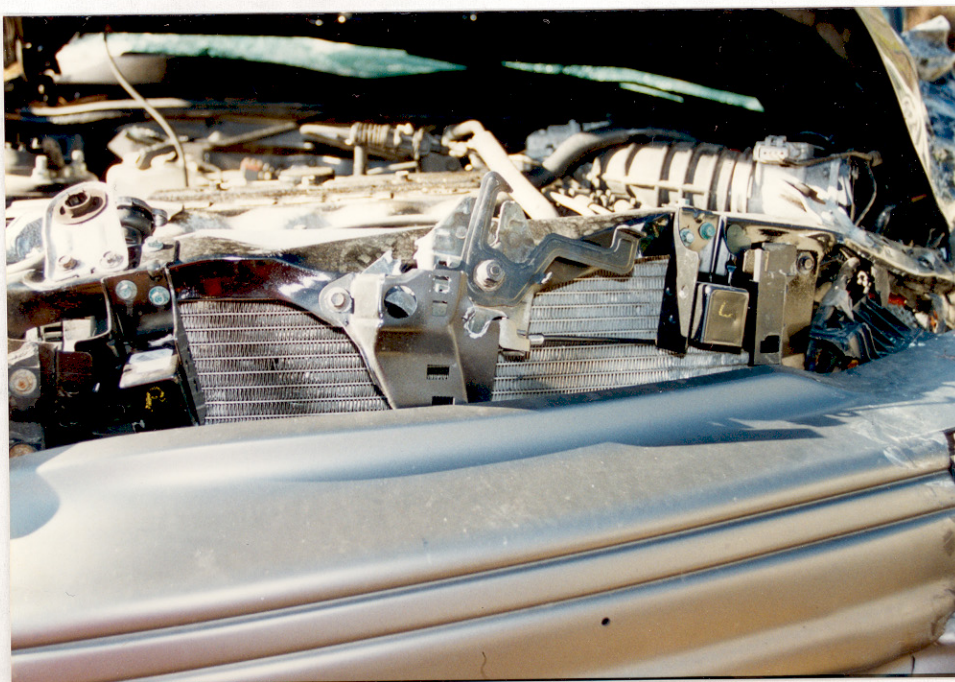
43. View of the direct contact damage to the left frontal plane.

The left front bumper of the 1995 Ford Escort (Vehicle #1) struck the left front bumper of the 1988 Jeep Cherokee (Vehicle #2). The damage profile represented a typical head-on contact pattern. Vehicle #1 sustained direct contact damage to the frontal plane starting 35.6 cm (14.0") left

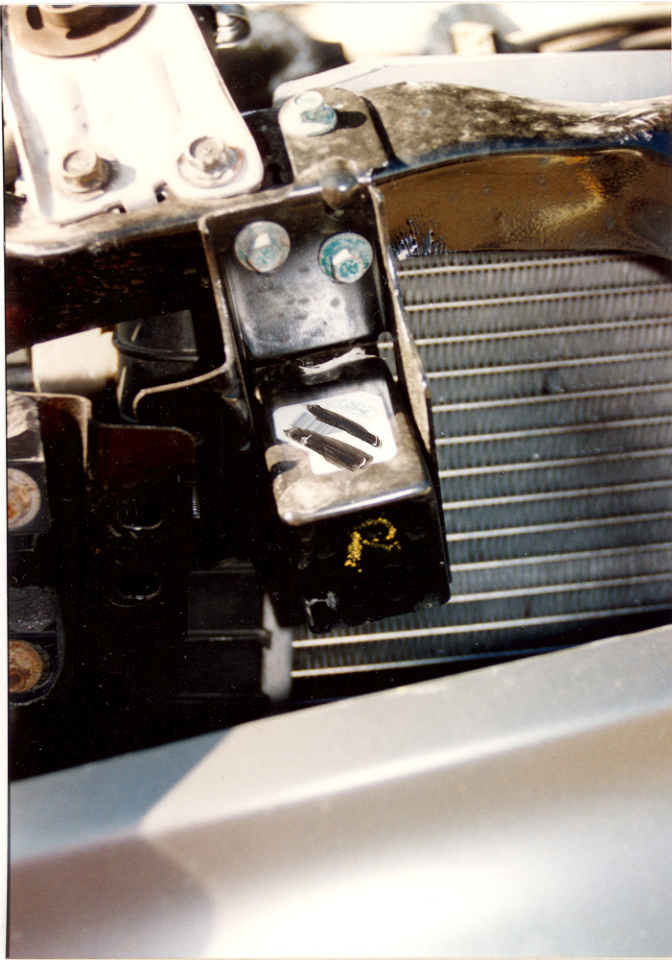
44. View of the damage to the upper radiator support bracket and crash sensors located on the upper radiator support bracket.

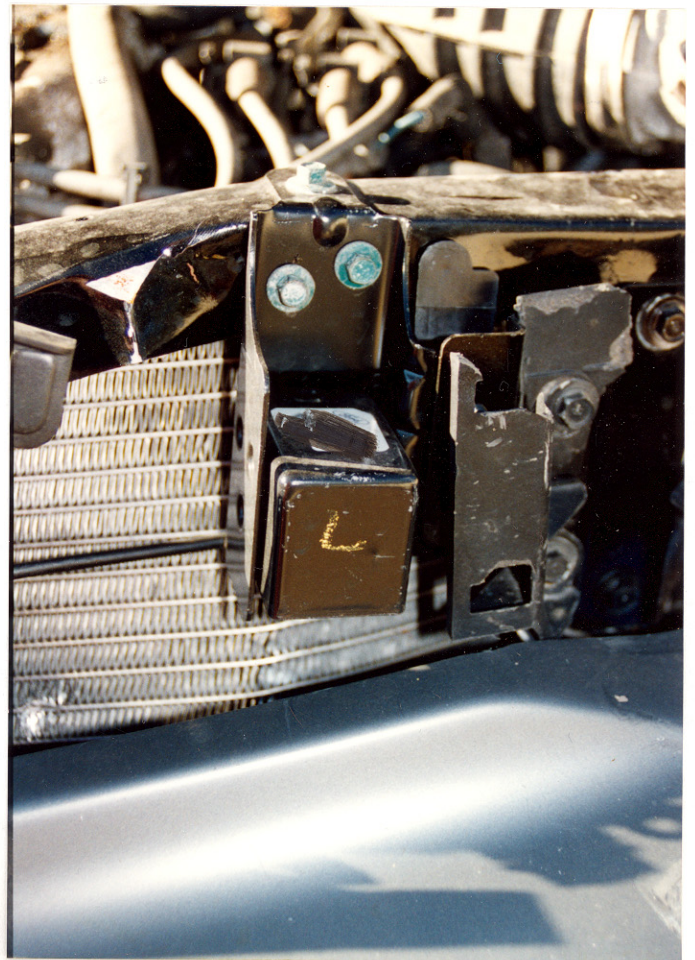
45. Close-up view of the damage to the right crash sensor.

Two crash sensors located on the radiator support bracket were damaged in the crash (refer to photographs #45 and #46 on page A-23). The driver side air bag module opened in the typical "H" pattern during the deployment sequence along the designated tear seam lines. The upper module flap measured 10.2 cm (4.0") vertically and continued 2.5 cm (1.0") horizontally to the top hinge point. The lower module flap measured 5.1 cm (2.0") vertically and also continued 3.8 cm (1.5") to the lower hinge point. The width of the flaps measured 17.1 cm (6.75") along the common horizontal

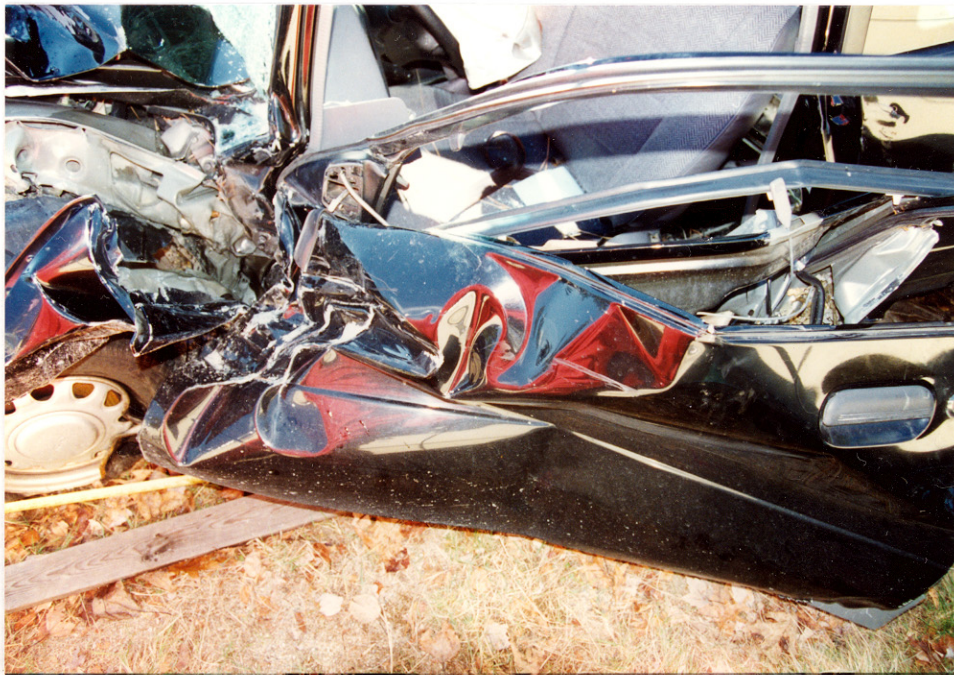
53. Vertical view of the left front door and rearward displacement of the upper left A-pillar.

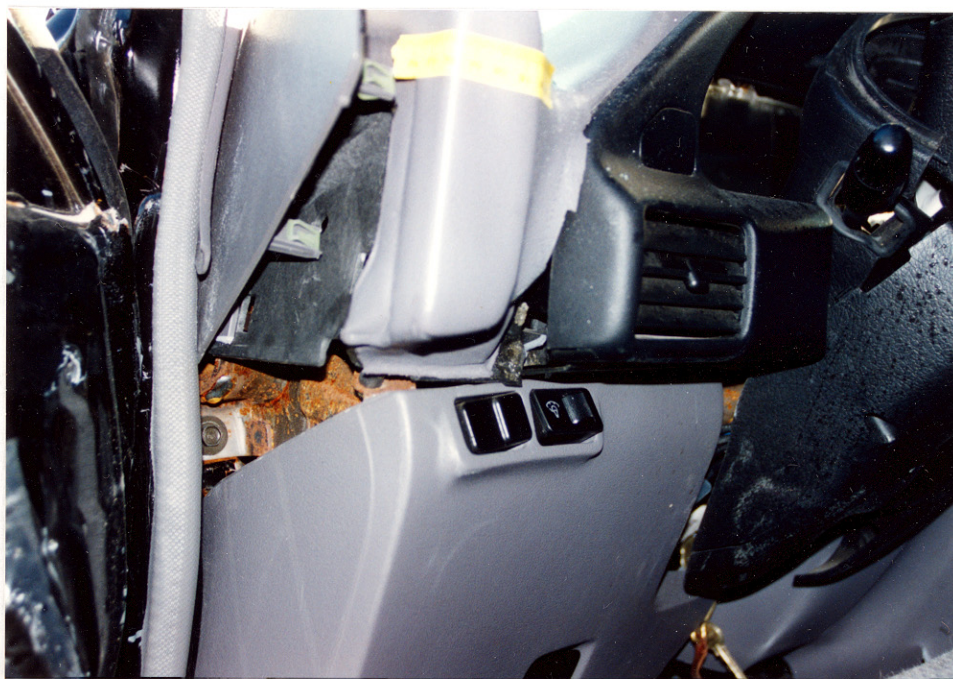
61. View of contact evidence on the left side of the instrument panel

A 2.5 cm (1.0") blue cloth transfer was noted on the vertical surface of the upper instrument panel below the side glass defroster (refer to photograph #61 on page A-31). A gouge in the vinyl covering was located on the top of the instrument panel 31.8 cm (12.5") left of the vehicle centerline (refer to photograph #72 on page A-36). A 3.8 cm (1.5") diameter whitish tissue transfer mark was located on the edge of the instrument panel eyebrow 11.4 cm (4.5") left of center (refer to photographs #73 and #74 on page A-37). Long strands of brown hair fibers were embedded in the fractured vinyl shroud covering the left A-pillar located 7.6 cm - 19.1 cm (3.0" - 7.5") below the roof header and 68.6 cm (27.0") left of the vehicle centerline (refer to photograph #70 on page A-35).

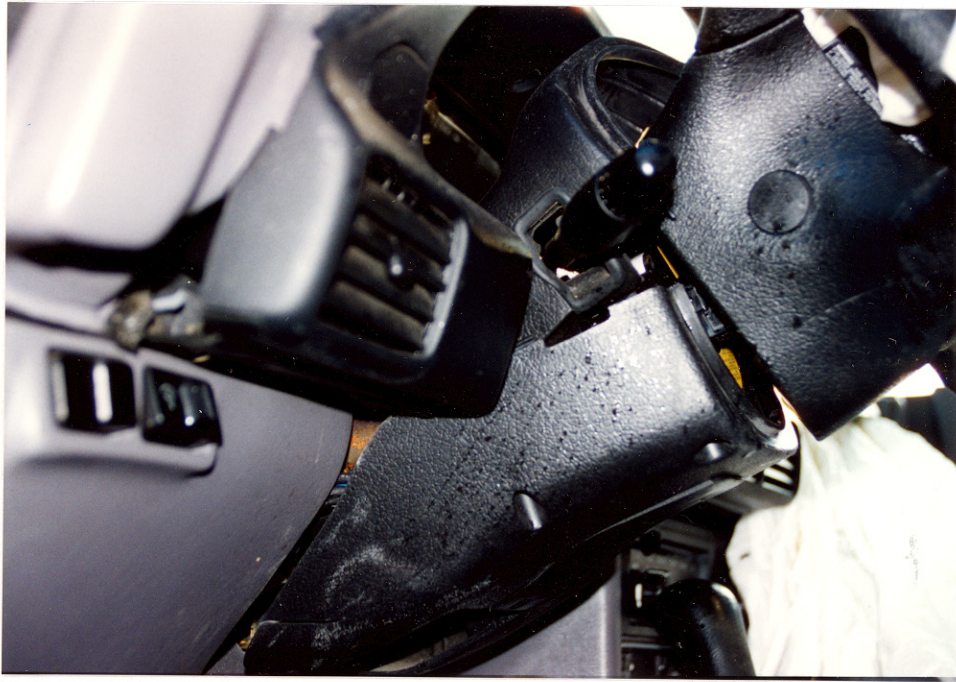
62. Close-up view of the occupant contact damage to the left side knee bolster.

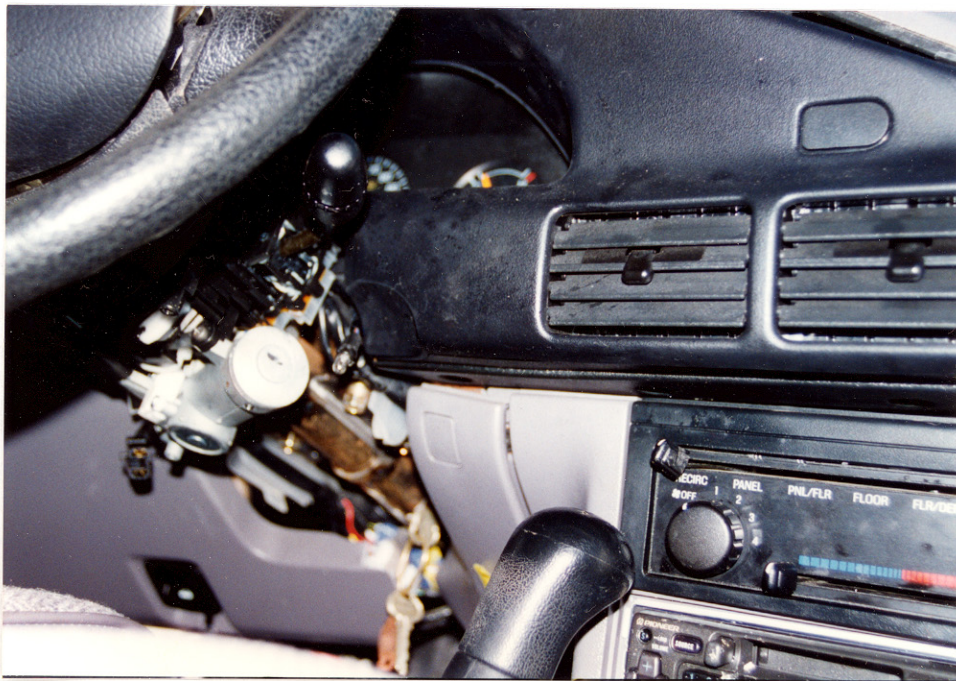
63. View from the left side showing the steering column forward displacement.

The steering column was displaced forward, however, there was no discernable sheer capsule visible (refer to photograph #63 on page A-32). The windshield wiper arm was bent rearward due to the forward displacement of the steering column. There was no steering wheel rim deformation. The hard vinyl knee bolster was fractured by the right knee of the driver as evidenced by a 8.9 cm (3.5") diameter tissue transfer measured 31.8 cm (12.5") left of the vehicle centerline (refer to photograph #64 on page A-33).

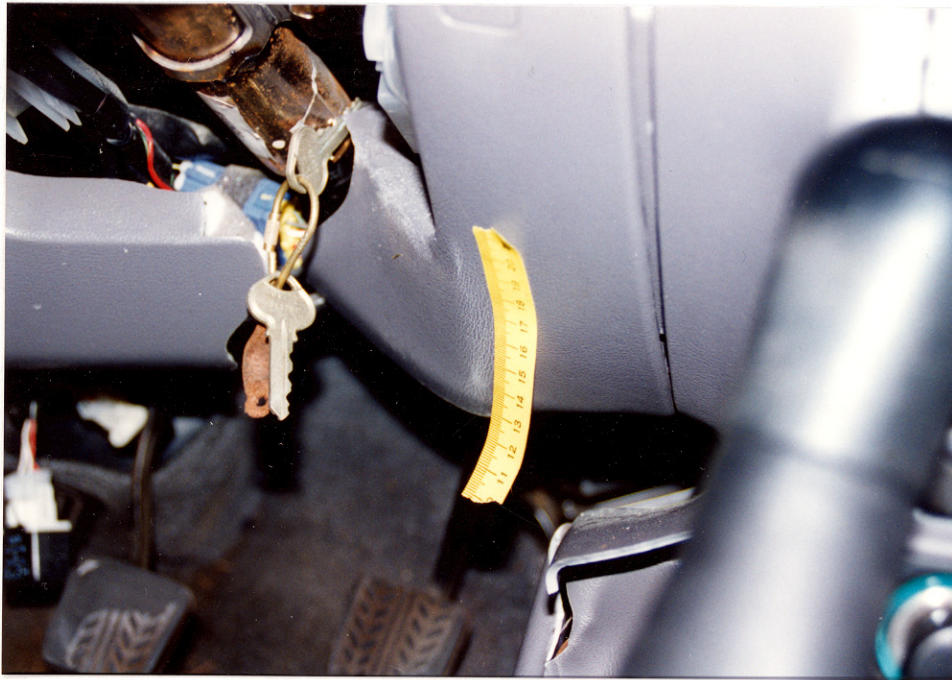
64. View of the damage to the left lower instrument panel.

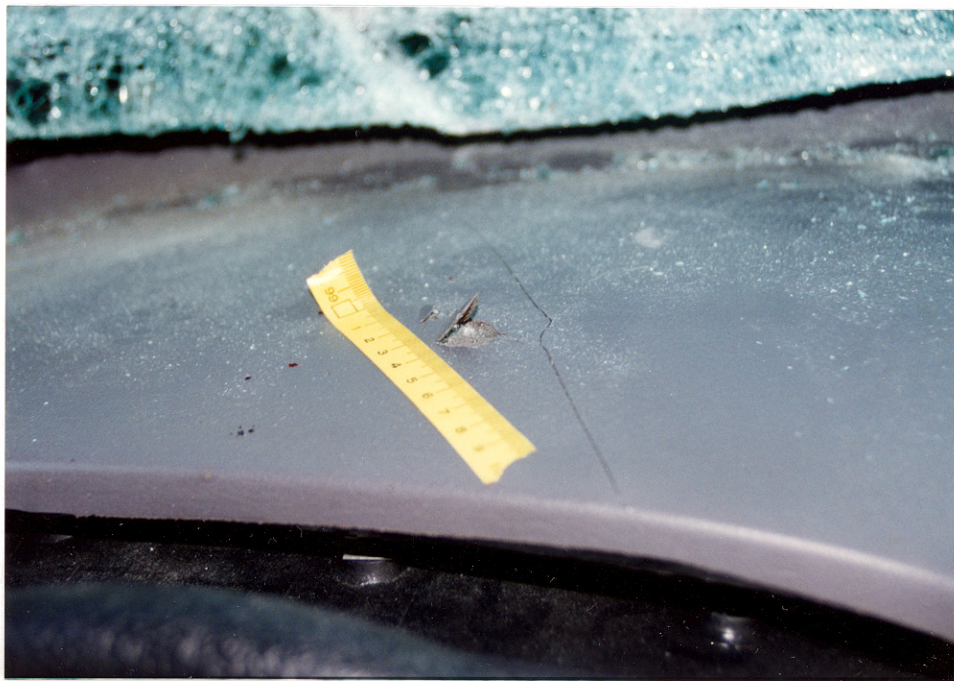
71. Vertical view of the left front instrument panel.

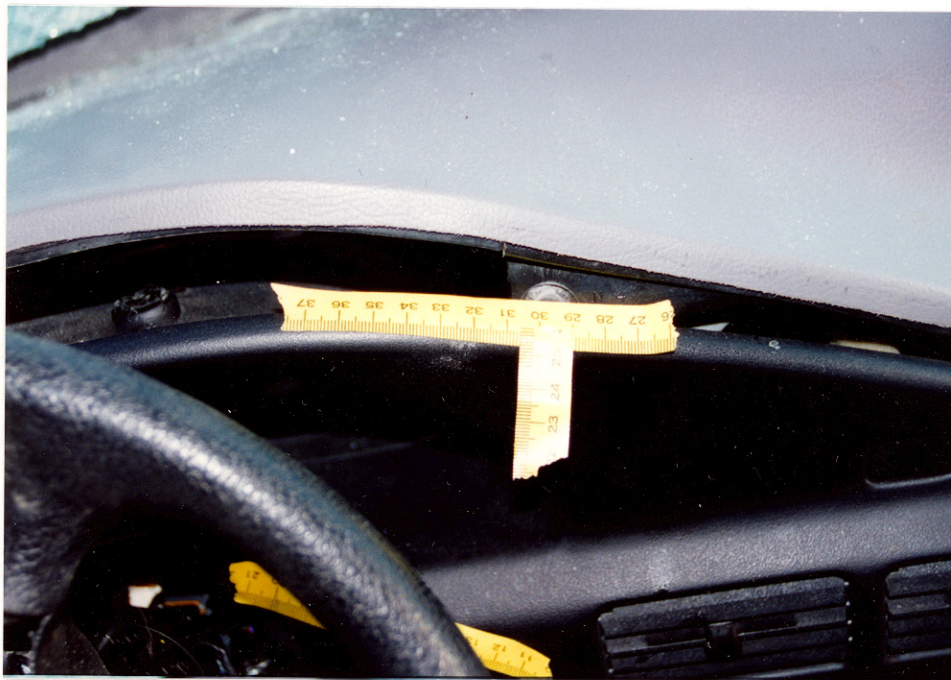
72. Close-up view of contact damage and bodily fluid on the left instrument panel.

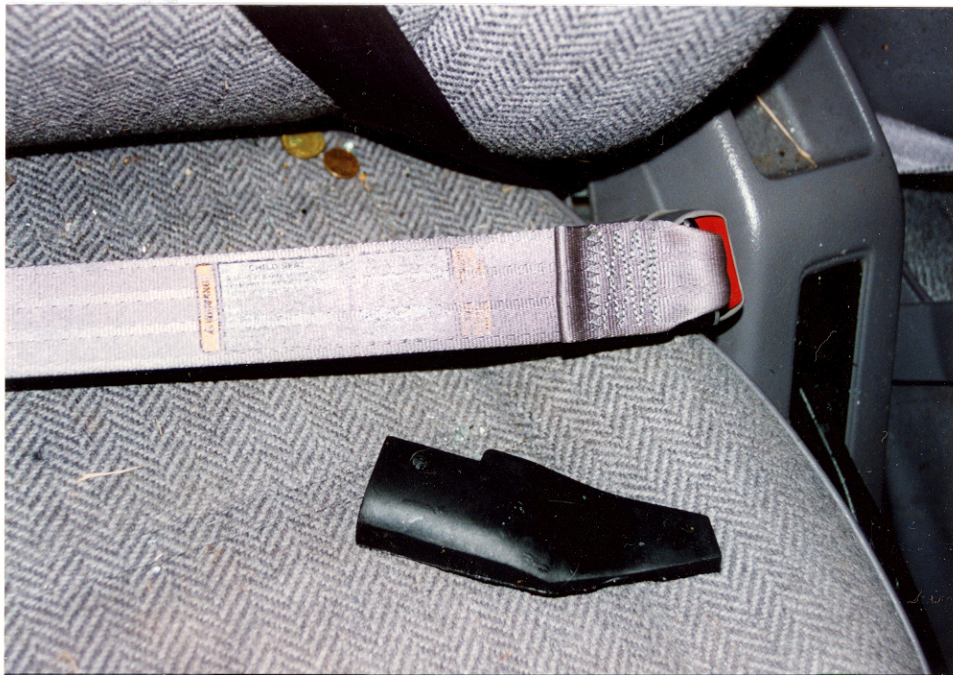
97. View of the right front passenger lap belt showing the child seat warning label.

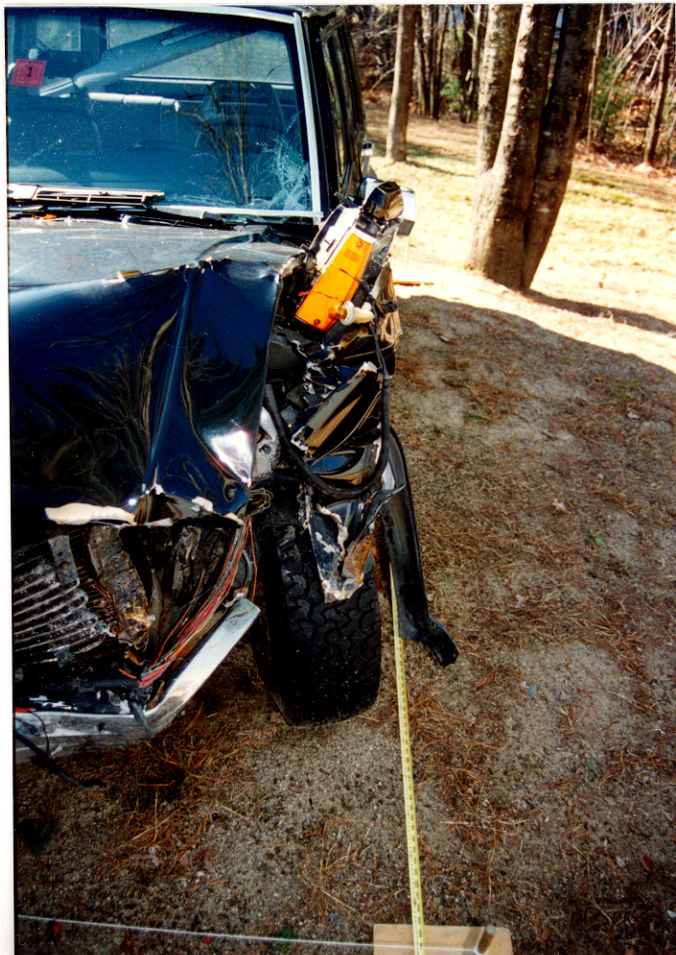
103. Close-up view of the left frontal plane of Vehicle #2 focusing on the damaged area.

The 1988 Jeep Cherokee Laredo sustained direct contact frontal damage which began 6.4 mm (0.25") right of the vehicle center and extended to the left front corner. The left front axle was displaced rearward 19.4 cm (7.7"). Maximum rearward displacement of 66.7 cm (26.25") was located at the left front corner. The crush values obtained at bumper level are listed below.

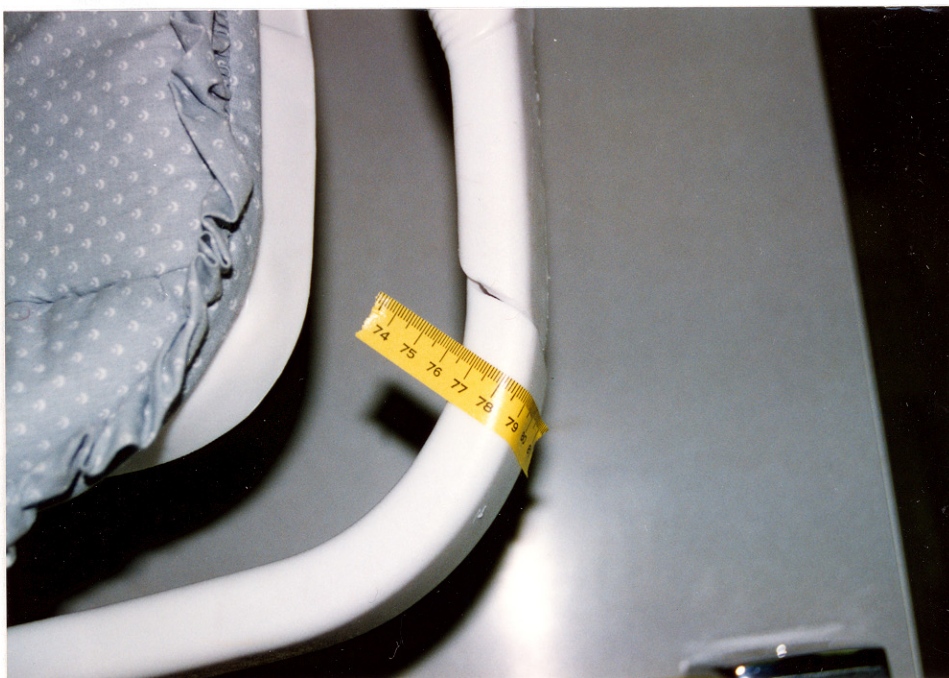
128. Overall view of the Century Infant Safety Seat

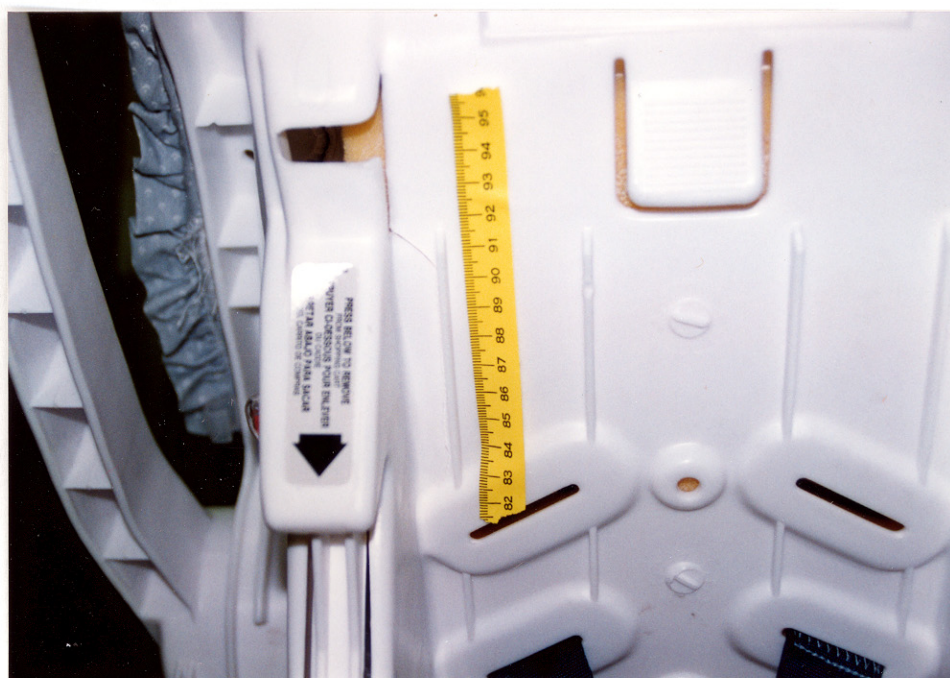
137. Close-up view of the abrasions and light black transfer mark on the rear surface of the safety seat shell from contact with the passenger side air bag module cover during the deployment sequence.

During the impact sequence, the supplemental inflatable restraint system (SRS) in Vehicle #1 actuated the deployment cycle. The passenger side air bag module cover rotated upward and contacted the rear surface of the child safety seat. This contact was noted by the abrasions and cracks sustained by the plastic shell of the safety seat. The seat was then propelled rearward by the expanding air bag and struck the dog which was moving forward in response to impact forces. It rebounded and came to rest on the right front seat cushion.

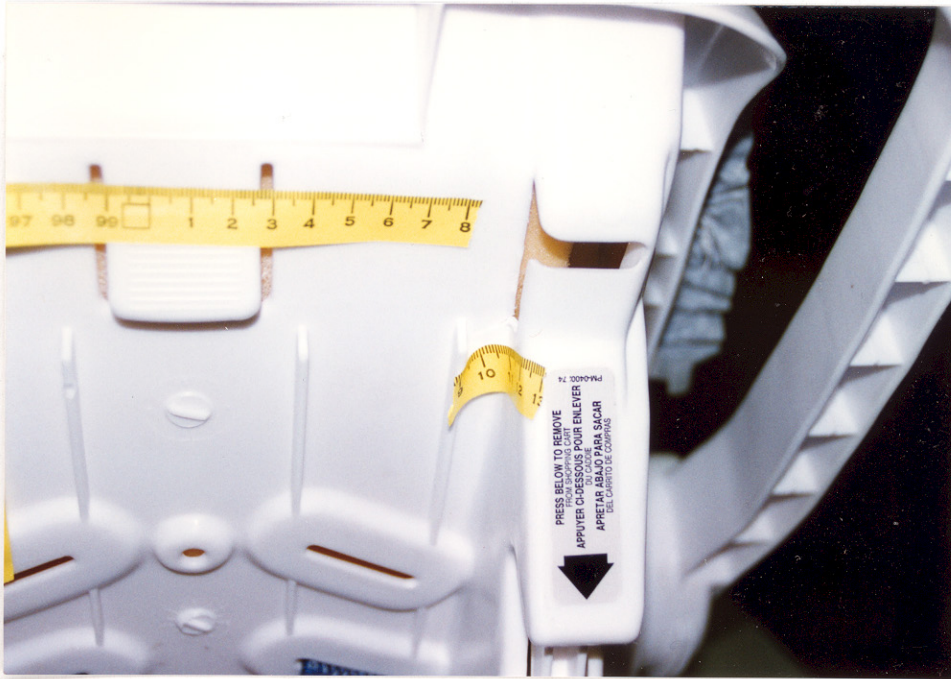
138. View of the crack in the rear left rear surface of the safety seat.

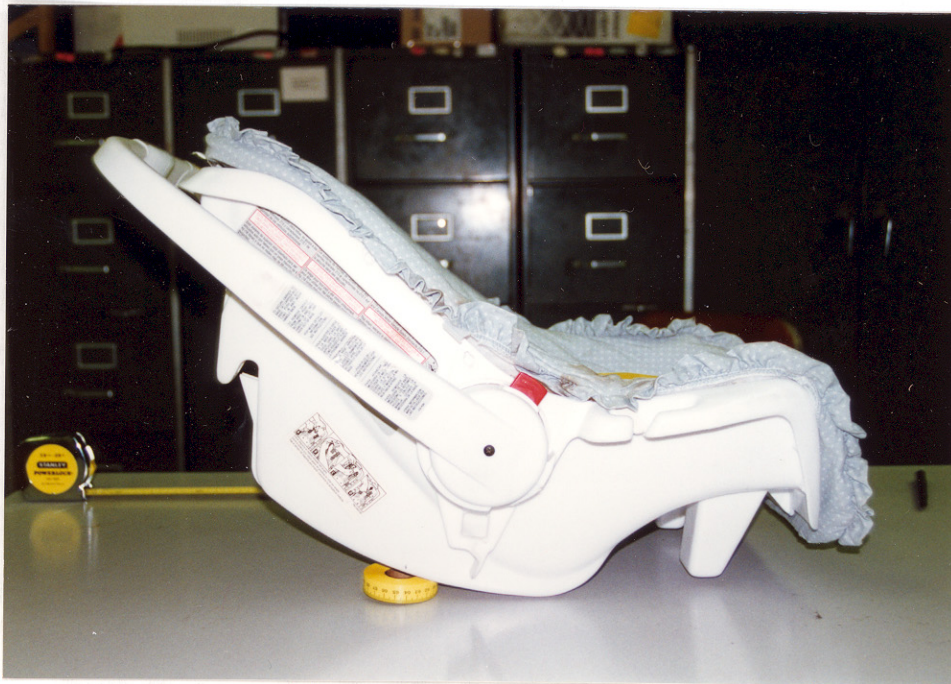
139. View of the crack in the safety seat shell located in the upper right rear plane of the safety seat shell.
